Parcel C Remedial Action

Project Update for Parcel C Hunters Point Naval Shipyard San Francisco, California

BCT Meeting September 26, 2013

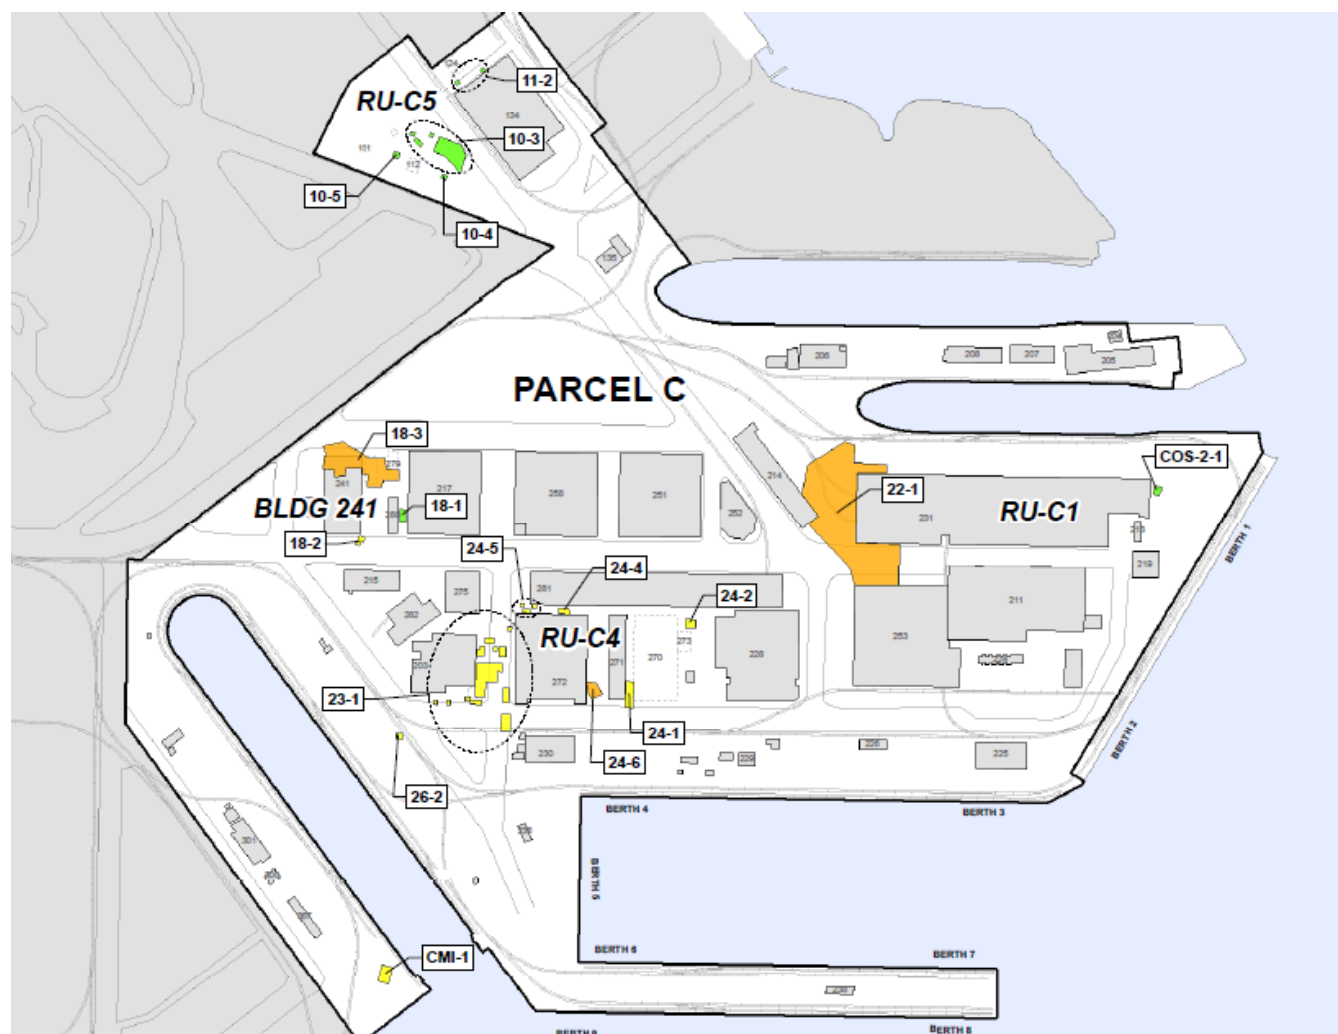
Excavation Progress

Approximately 17,300 bcy have been excavated and stockpiled (Sep 20, 2013). A total of 22,300 bcy is anticipated to be removed (not including step-outs and/or benching).

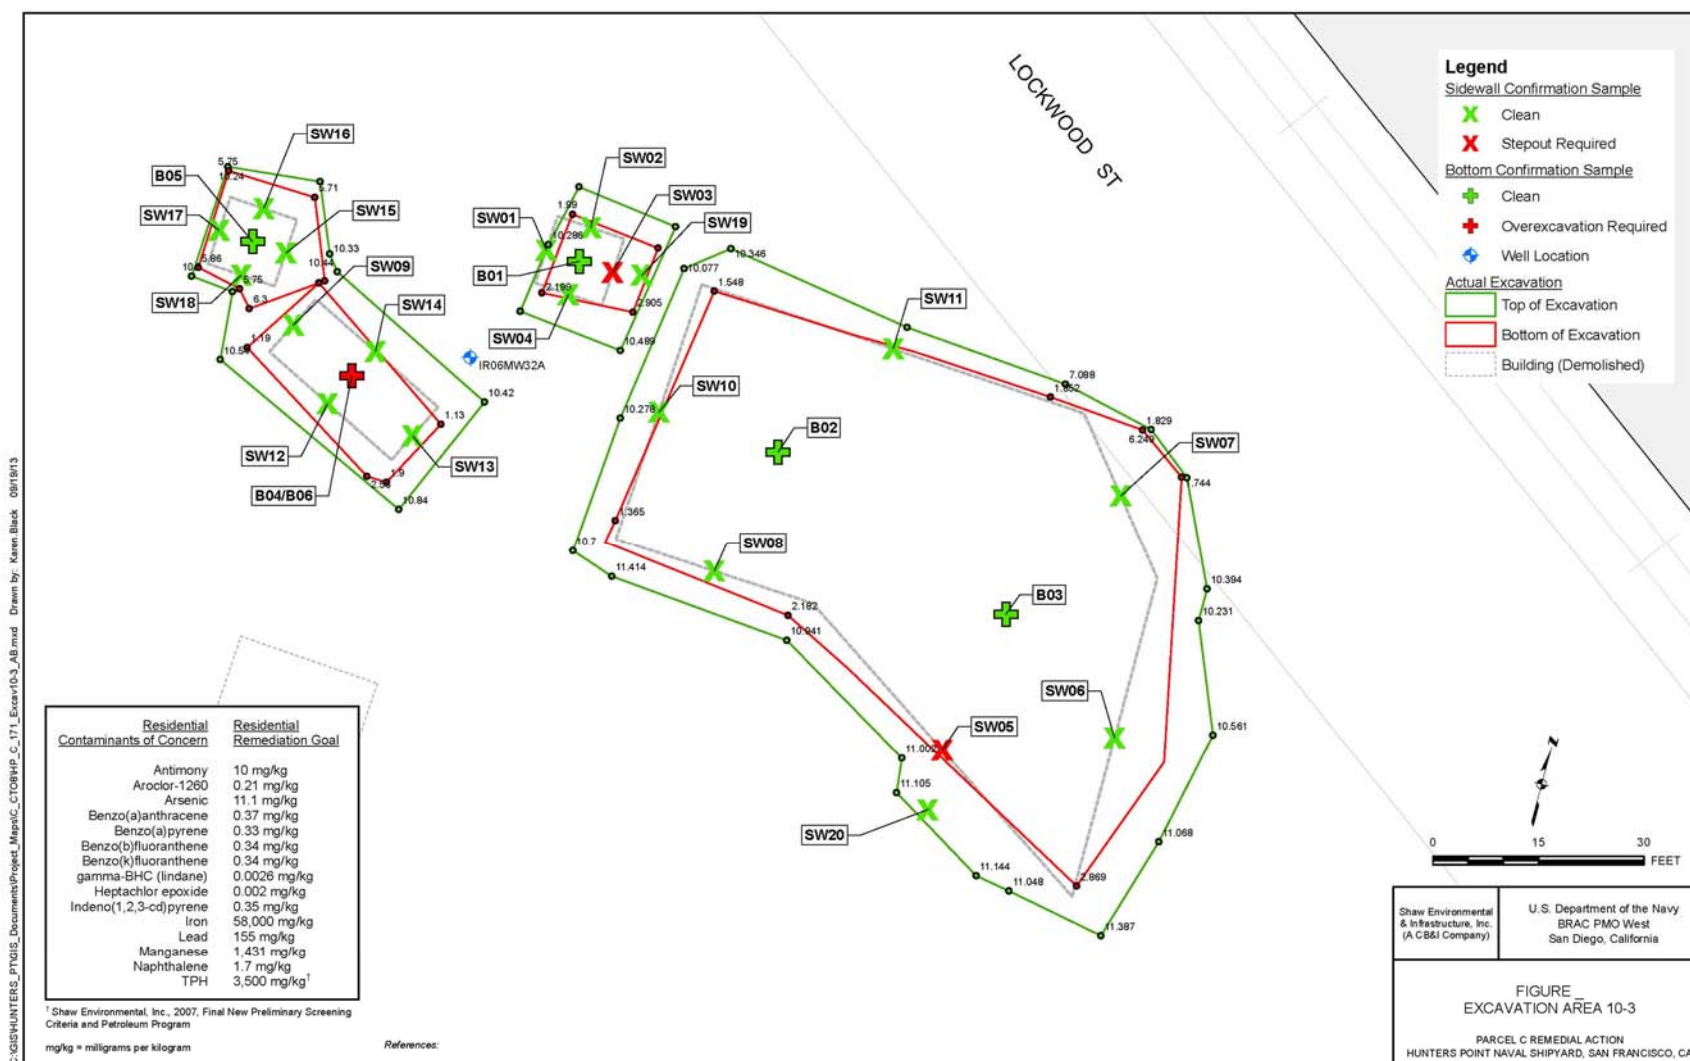
RU-C5 Excavation 10-3

At 10-3:

- Three locations needed step-outs:

Site	Type	Depth (ft)	PAHs	Metals	TPHs	OCP	PCB
10-3	B04	10	ok	Mn 2,570 mg/kg	ok	ok	ok
10-3	SW03	7	ok	ok	tTPH 7,184.3 mg/kg	ok	ok
10-3	SW05	3	ok	Mn 1,590 mg/kg	ok	ok	ok

- Three locations were over-excavated (approx 80 cy) - Confirmation samples now below cleanup goal:

Site	Type	Depth (ft)	PAHs	Metals	TPHs	OCP	PCB
10-3	B06	11	ok	ok	ok	ok	ok
10-3	SW19	7	ok	ok	ok	ok	ok
10-3	SW20	3	ok	ok	ok	ok	ok

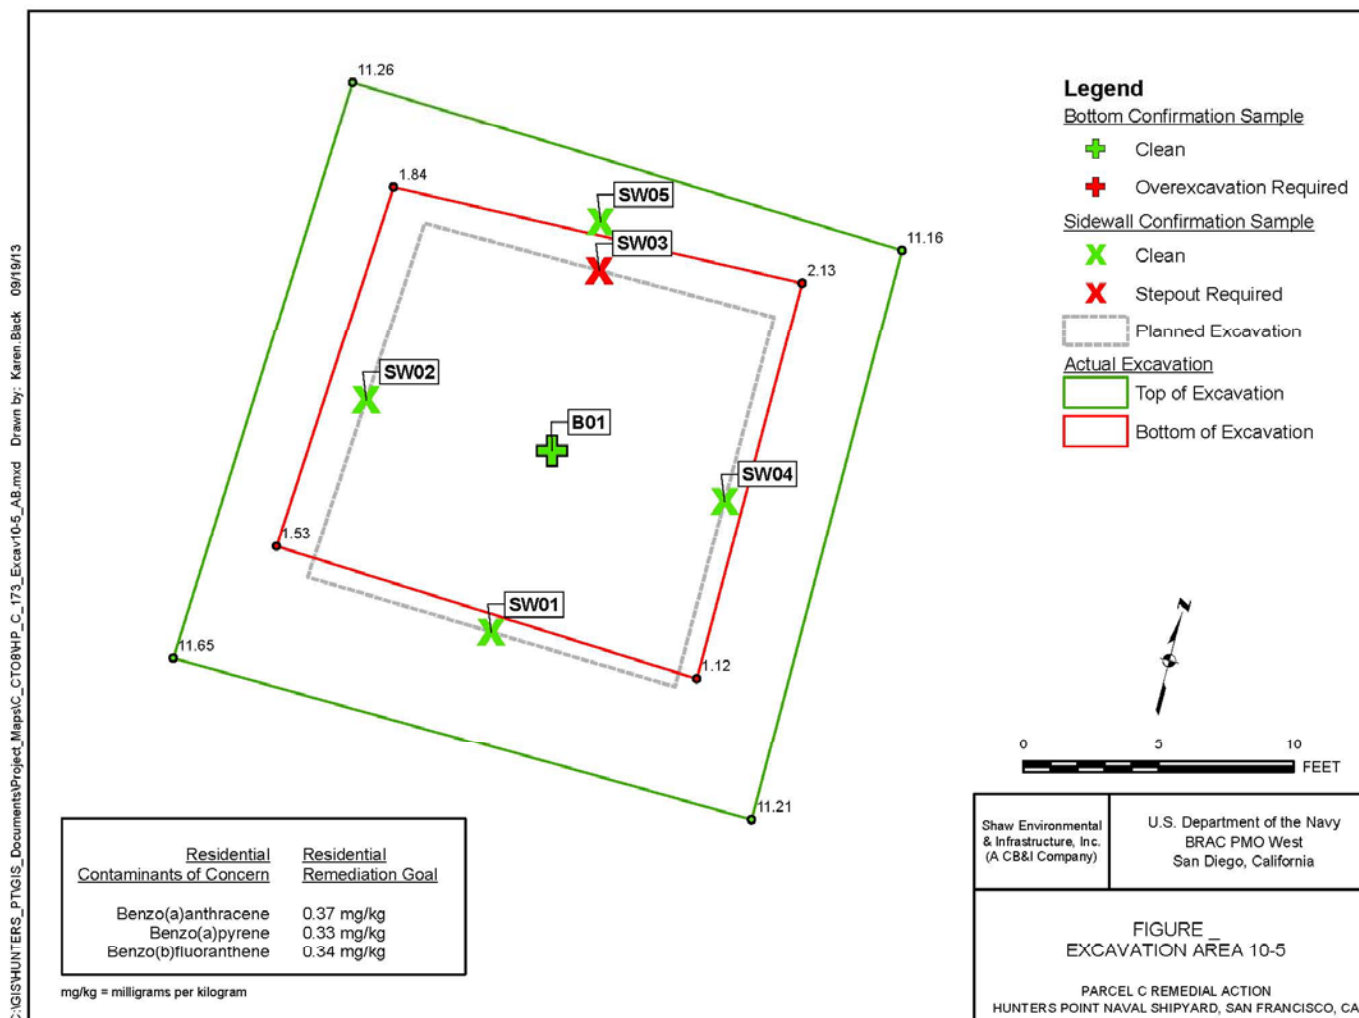
RU-C5 Excavation 10-5

At 10-5:

- One location needed a step-out:

Site	Type	Depth (ft)	PAHs	TPHs
10-5	SW03	8	ok	tTPH 8,925 mg/kg

- The location was over-excavated (approx 16 cy) - Confirmation sample now below cleanup goal:

Site	Type	Depth (ft)	PAHs	TPHs
10-5	SW05	8	ok	ok

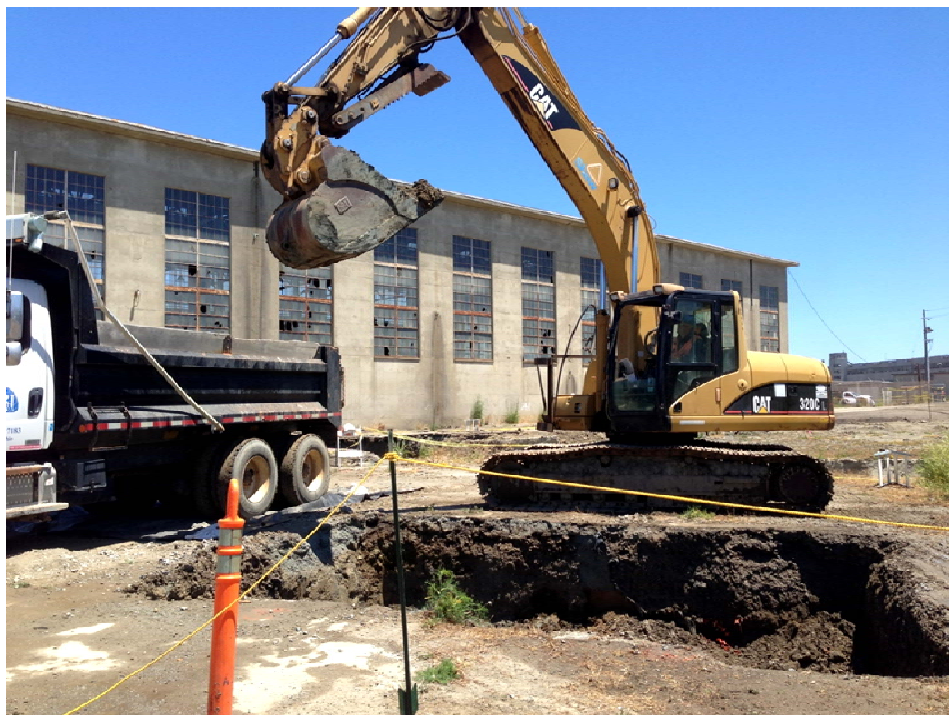
Excavation at 10-3, RU-C5 looking southeast
– July 18, 2013

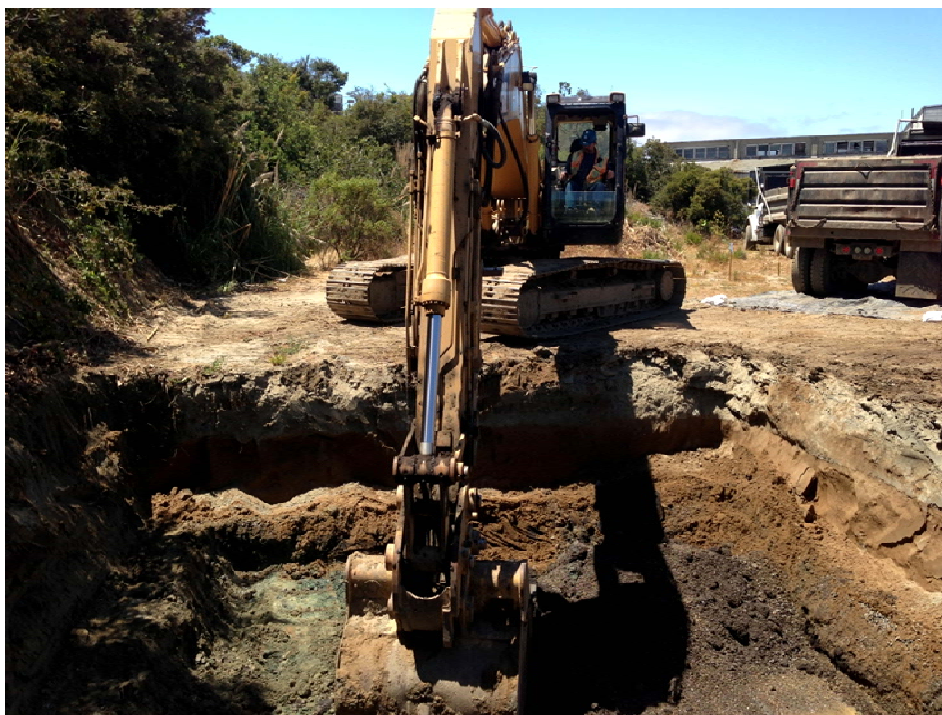
Excavation at 10-5, RU-C5 looking west – July 26, 2013

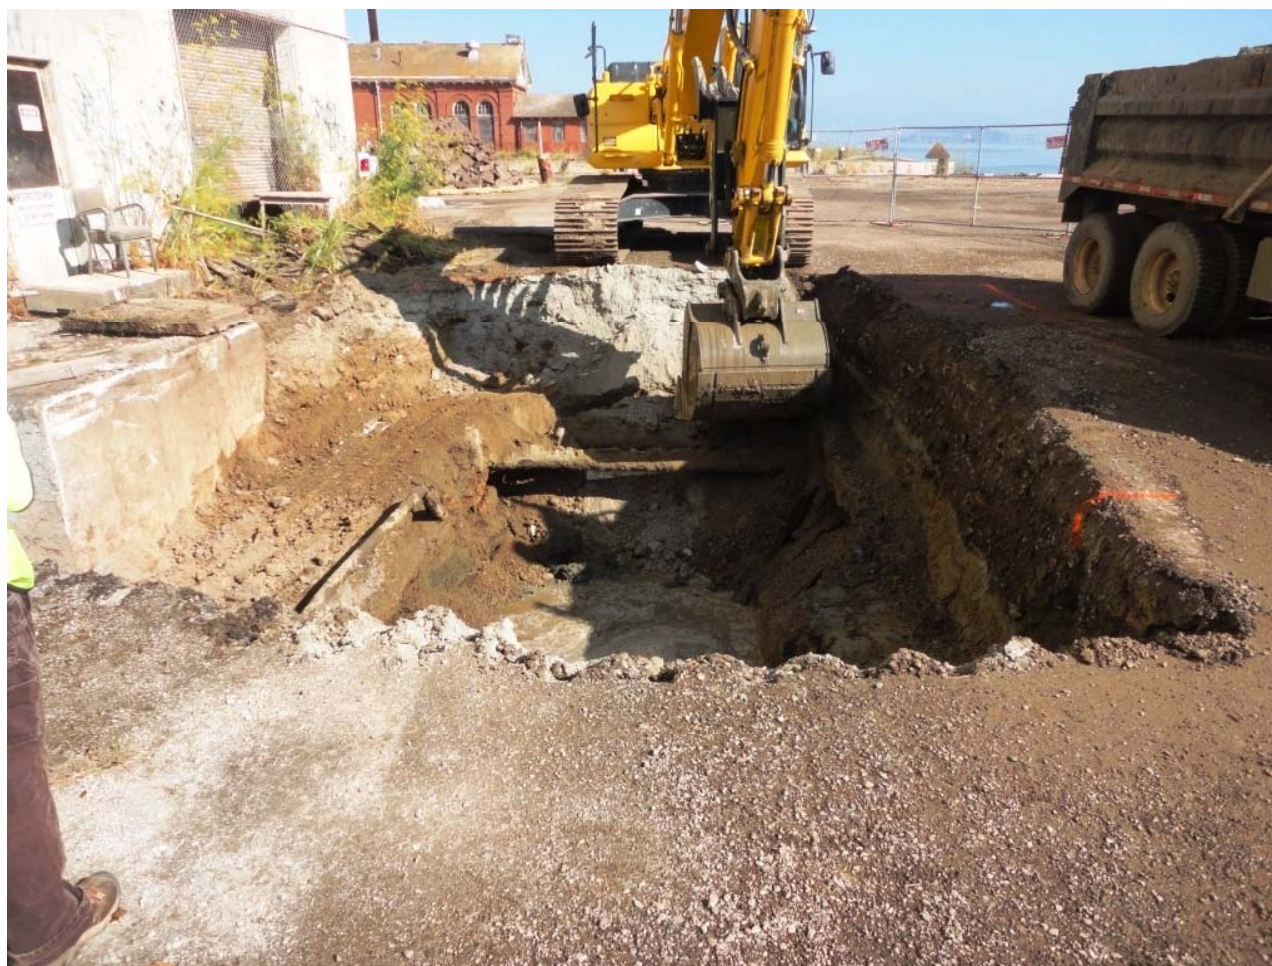
RU-C1 Excavation COS-2-1

Excavation of COS-2-1 looking northwest – August 13, 2013

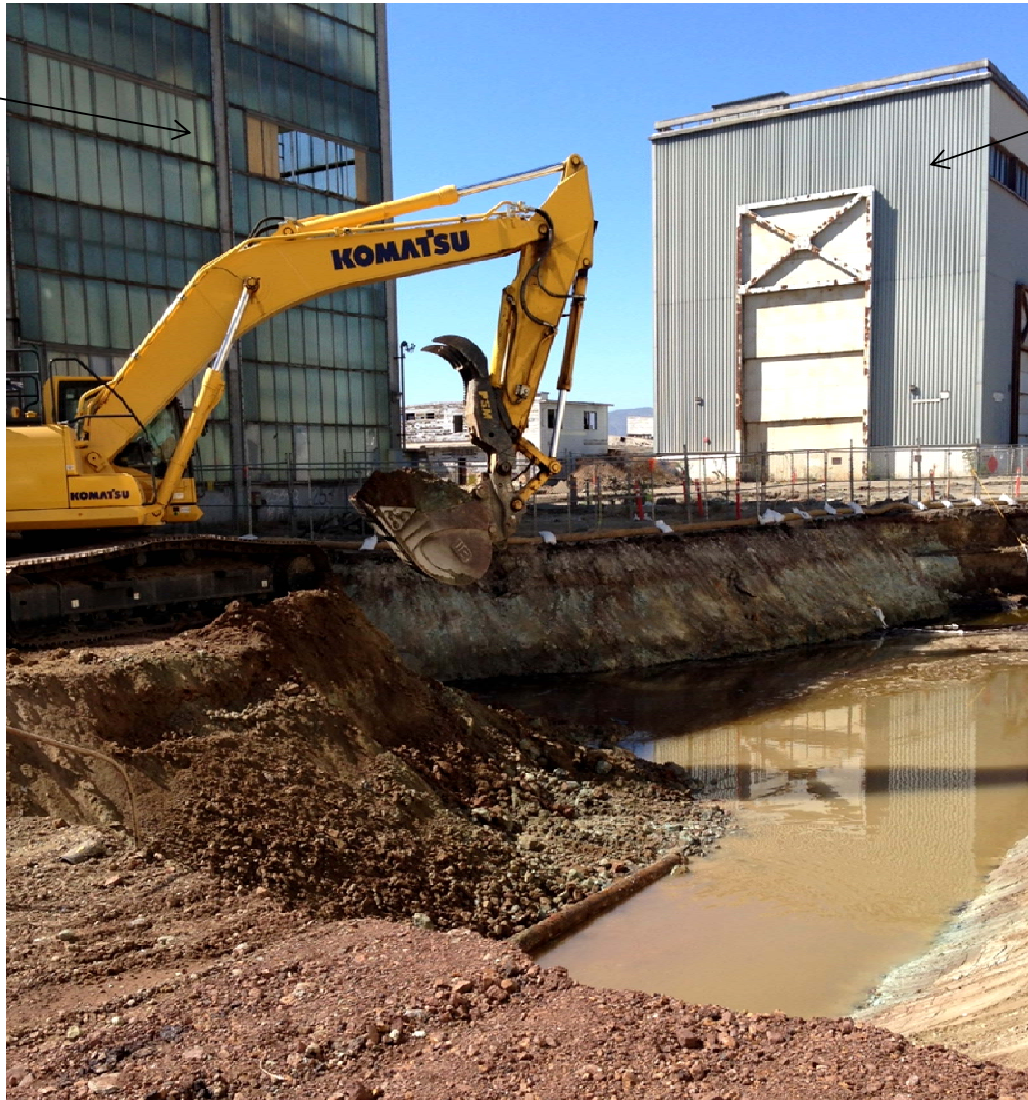
RU-C1 Excavation 22-1

Excavation between Buildings 231 (not shown on photo) and 253 at Excavation 22-1 looking southwest – August 19, 2013

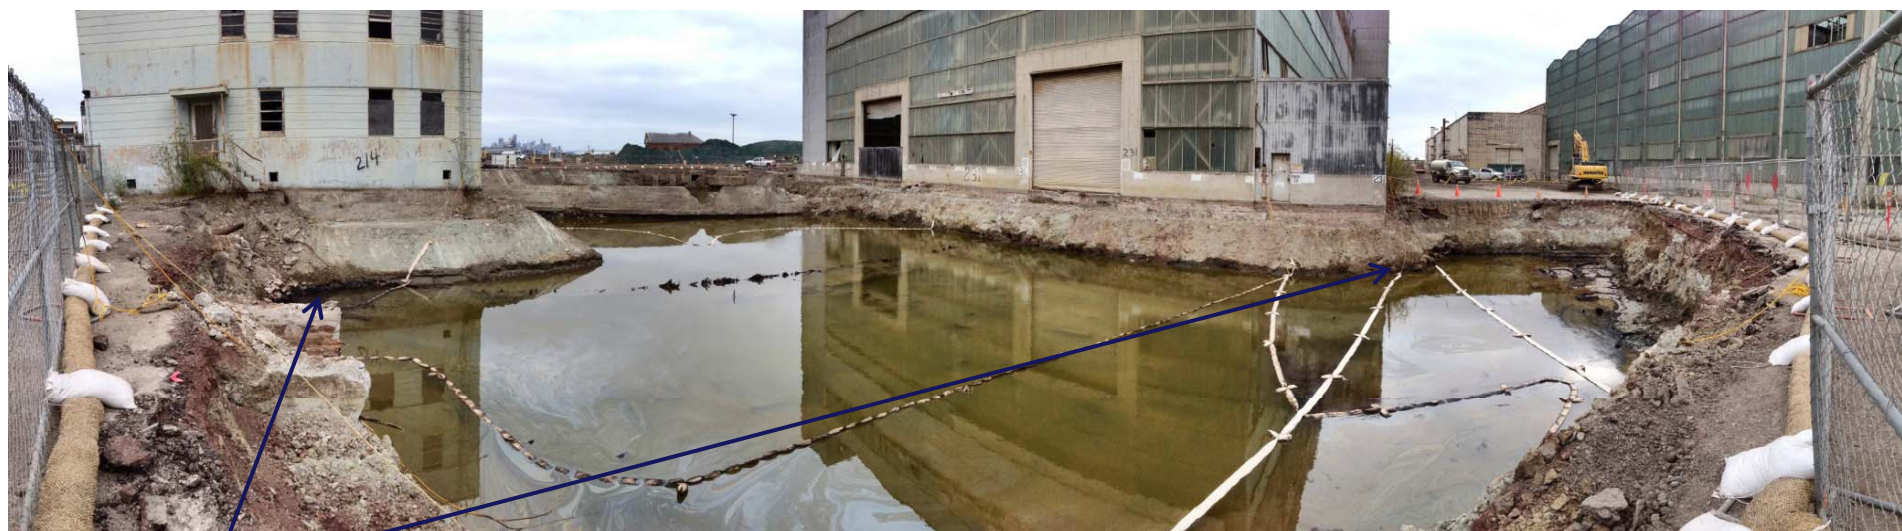
RU-C1 Excavation 22-1

TPH observed

Panoramic view of Excavation 22-1 facing east – September 2013

- Continue excavation of 22-1 and over-excavate locations as needed when confirmation sample results are received
- Commence backfilling of excavations that meet cleanup goals (starting in RU-C5)

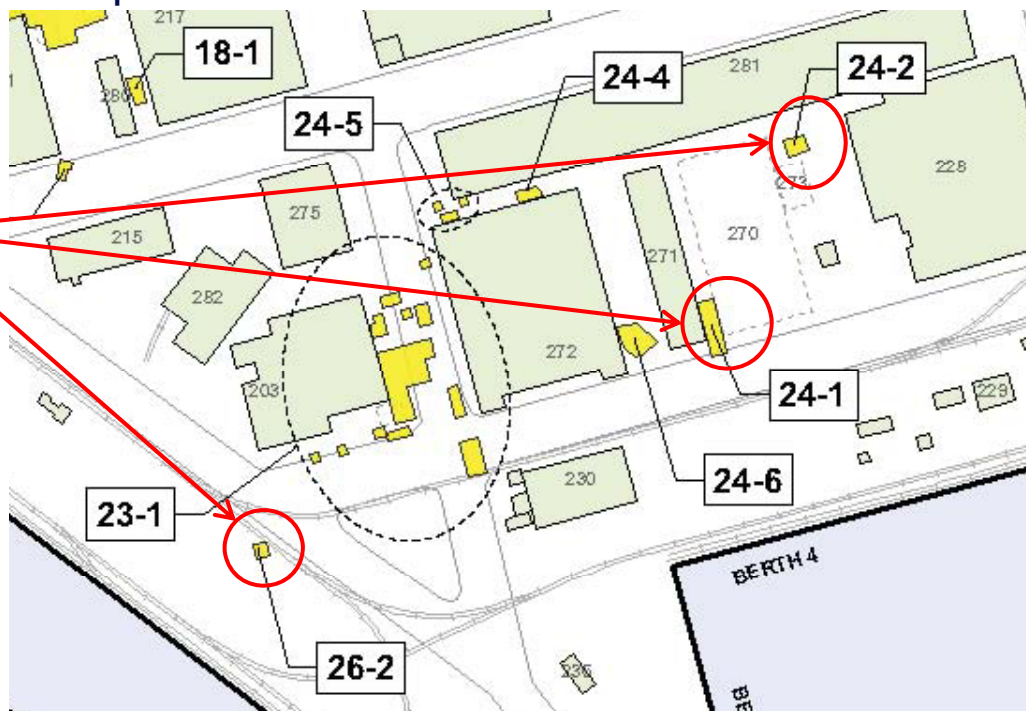
Areas still behind RCA fence

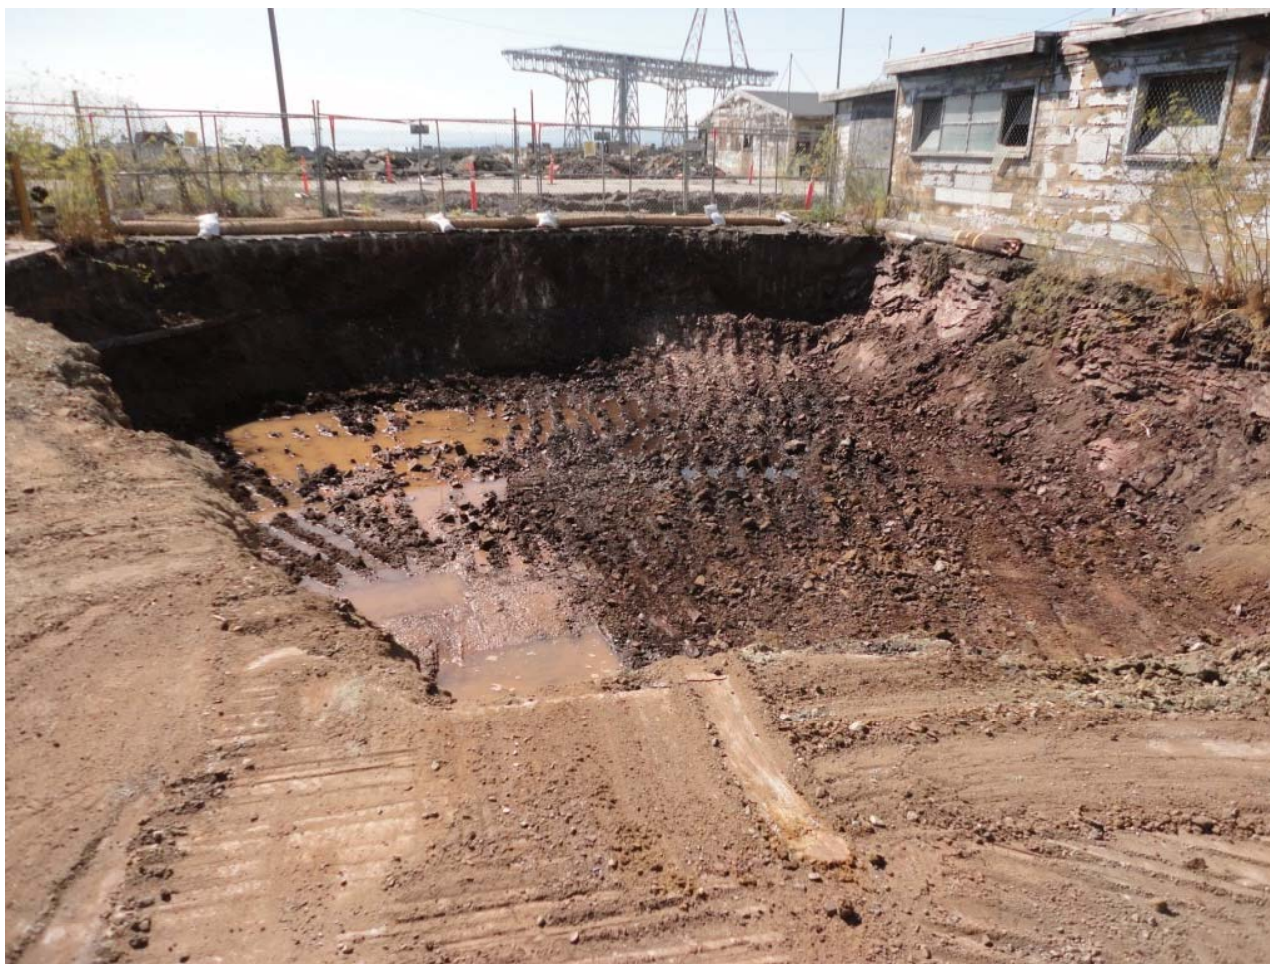
RU-C4 Excavation 24-6

Excavation 24-6 footprint looking south; over-excavations planned – September 9, 2013

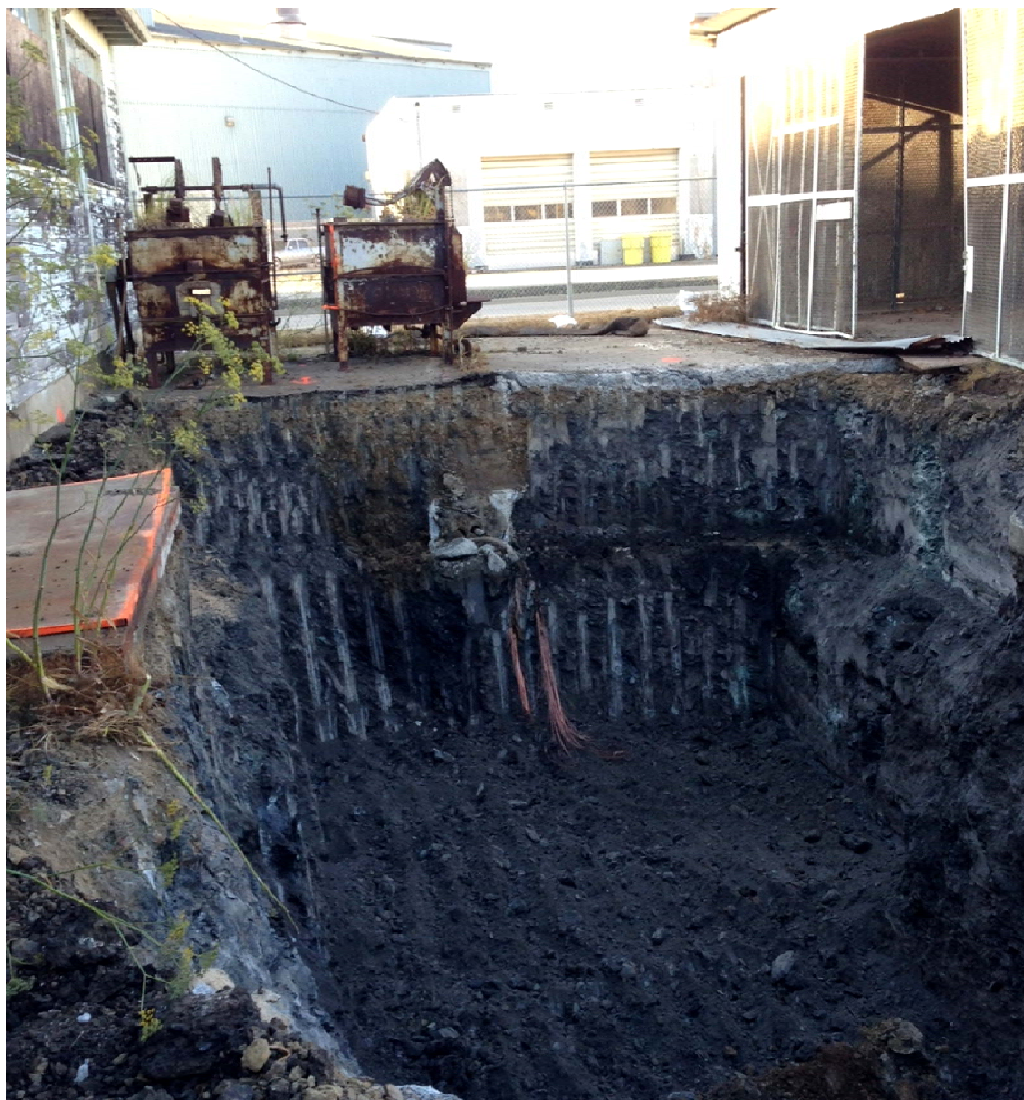
Building 241 Excavation 18-1

18-1 excavation complete;
looking south near
Building 217 –
September 4, 2013

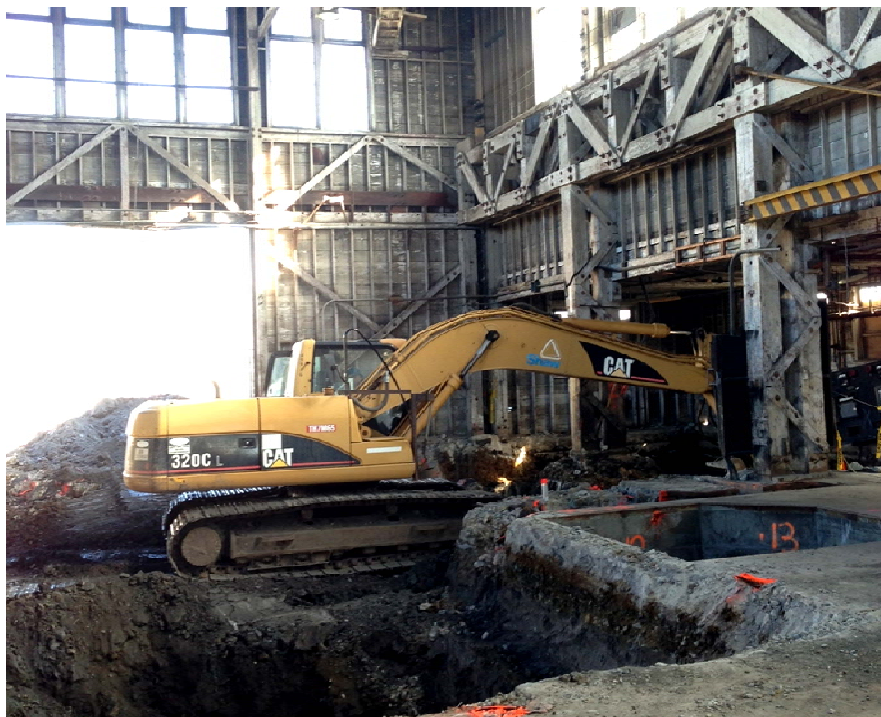
Building 241 Excavation 18-3

Excavation 18-3 within Building 241 looking northwest – September 5, 2013

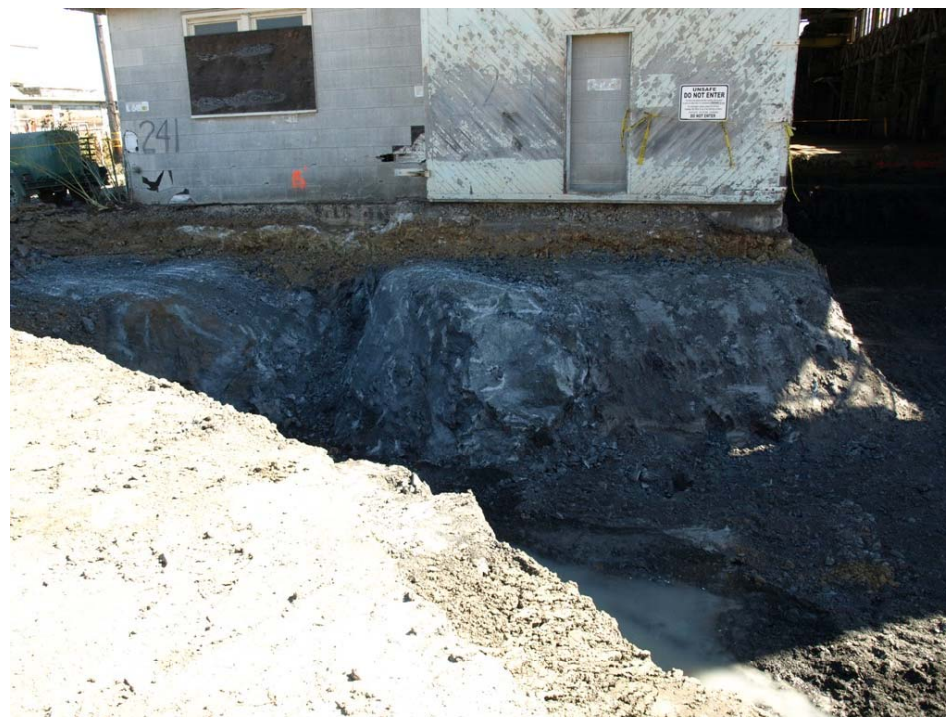
Exposed bedrock at excavation 18-3 looking west – September 18, 2013

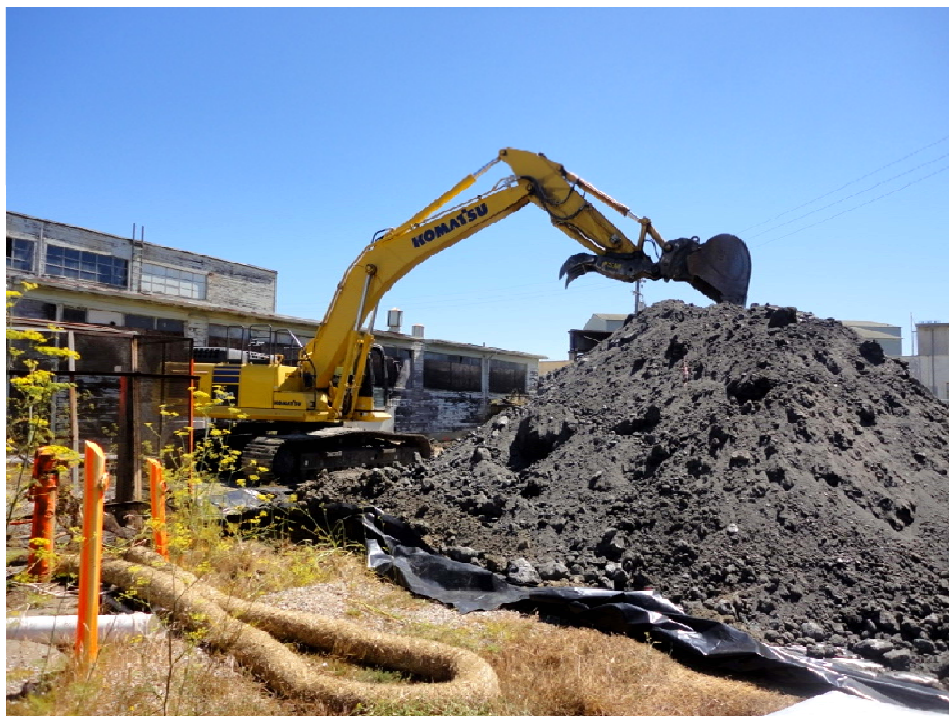
Excavation 18-1 stockpiling between Buildings 241 and 217 looking southwest – September 4, 2013

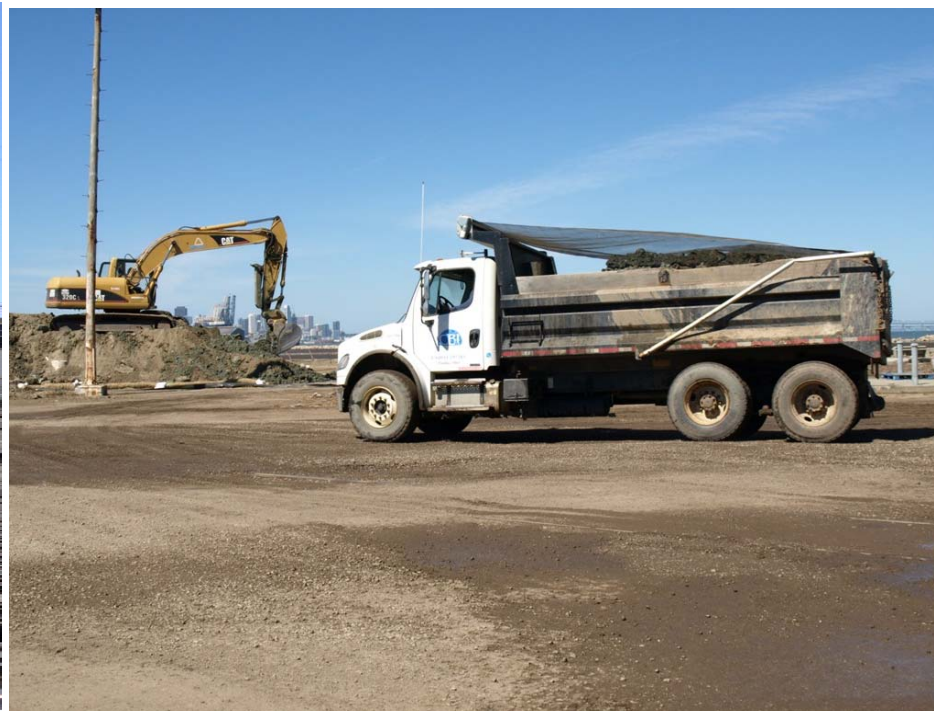
Tarped dump truck with Parcel C excavated soil – September 18, 2013
